EPM

For the provision of transparent information on mining

Enhanced Pollution Monitoring – How it works

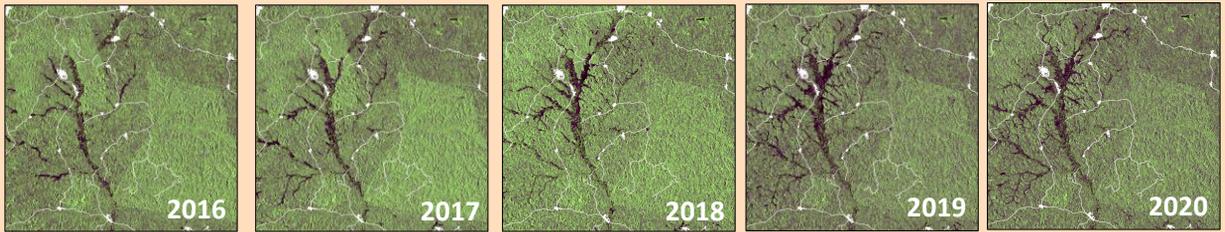
Sentinel-1 is operationally delivering data since 2015. This allows, for the first time ever, to retrospectively quantify annual ASM evolution rate, as shown as example in the figures below.

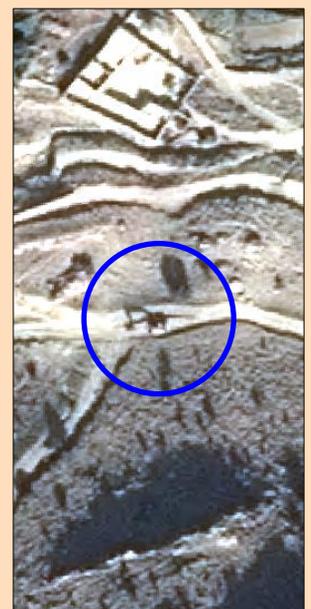
Given the rugged nature of the terrain and the small mining plots in Nangahar province, a detailed Digital Elevation Model (DEM) is essential to provide an accurate map. For this reason, a DEM at 3 meter resolution is produced from SPOT-6 stereo images. Subsequently, based on 30 meter Landsat-5/8 data, the evolution of the talc mining extent for 2008, 2014, and 2017 is mapped and overlaid on the DEM. As shown in the upper figure, there is clear evidence that the most significant growth occurred between 2008 and 2014, while from 2015 the mining extent remained practically stable. To assess the effective exploited area, a 0.5 meter Pleiades image acquired in 2016 is used, the talc mining area mapped (bottom figure) and calculated, resulting in around 85 hectares. Moreover, this very high resolution image permits to identify an excavator (blue circle), indicating a probable relevant talc production.

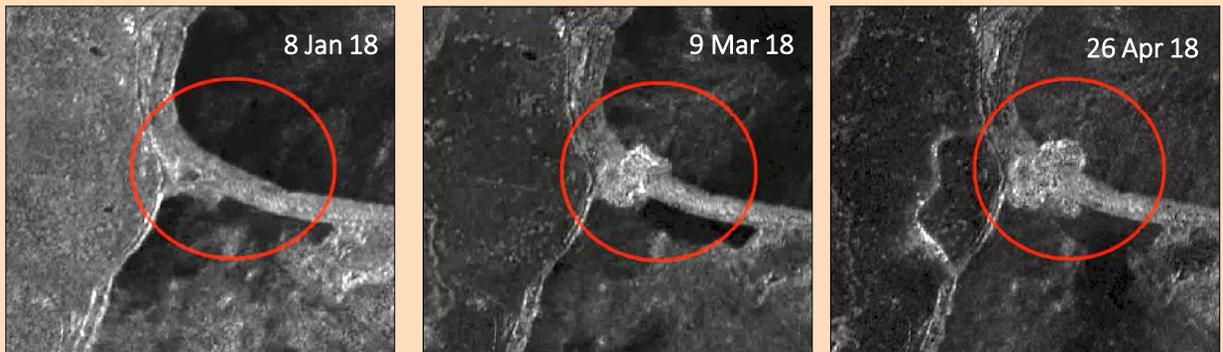
The three selected Sentinel-1 images show the dam status prior to the wall collapse (January 8th), at day of collapse (March 9th) and around one and half month later (April 26th), where it may be seen that the leakage is still on-going.

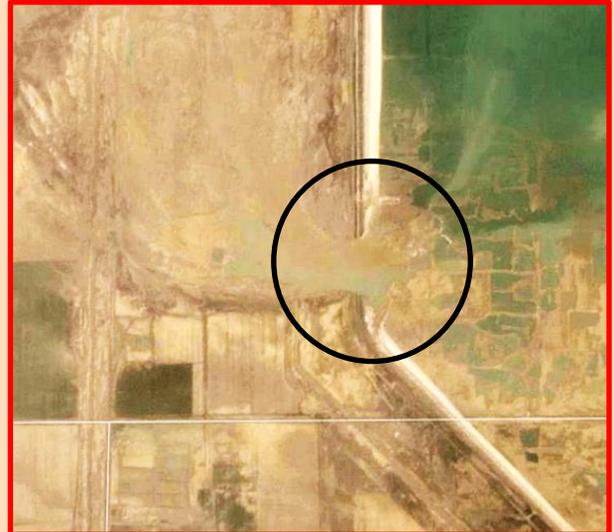
The temporal color image (left) composed from a combination of Sentinel-1 data acquired before and after (May 5th) the event, make it easy to see the flood water appearing blue. The box in the color composite image precisely indicates the location and the size of the dam failure, perfectly visible in Planet's PlanetScope 3 meter image (right) captured on May 3rd, 2020.
